Application of Remote Sensing and GIS for Tsunami Warning System

Abstract: Tsunami occurred on December 26th, 2004 and caused heavy losses of lives and properties along the western coast of Thailand, especially in the six provinces along the Andaman Sea. In order to prepare for such unpredictable natural disaster, Tsunami Warning System Committee agreed to establish tsunami warning towers in the six provinces along the Andaman coastline as the first priority.

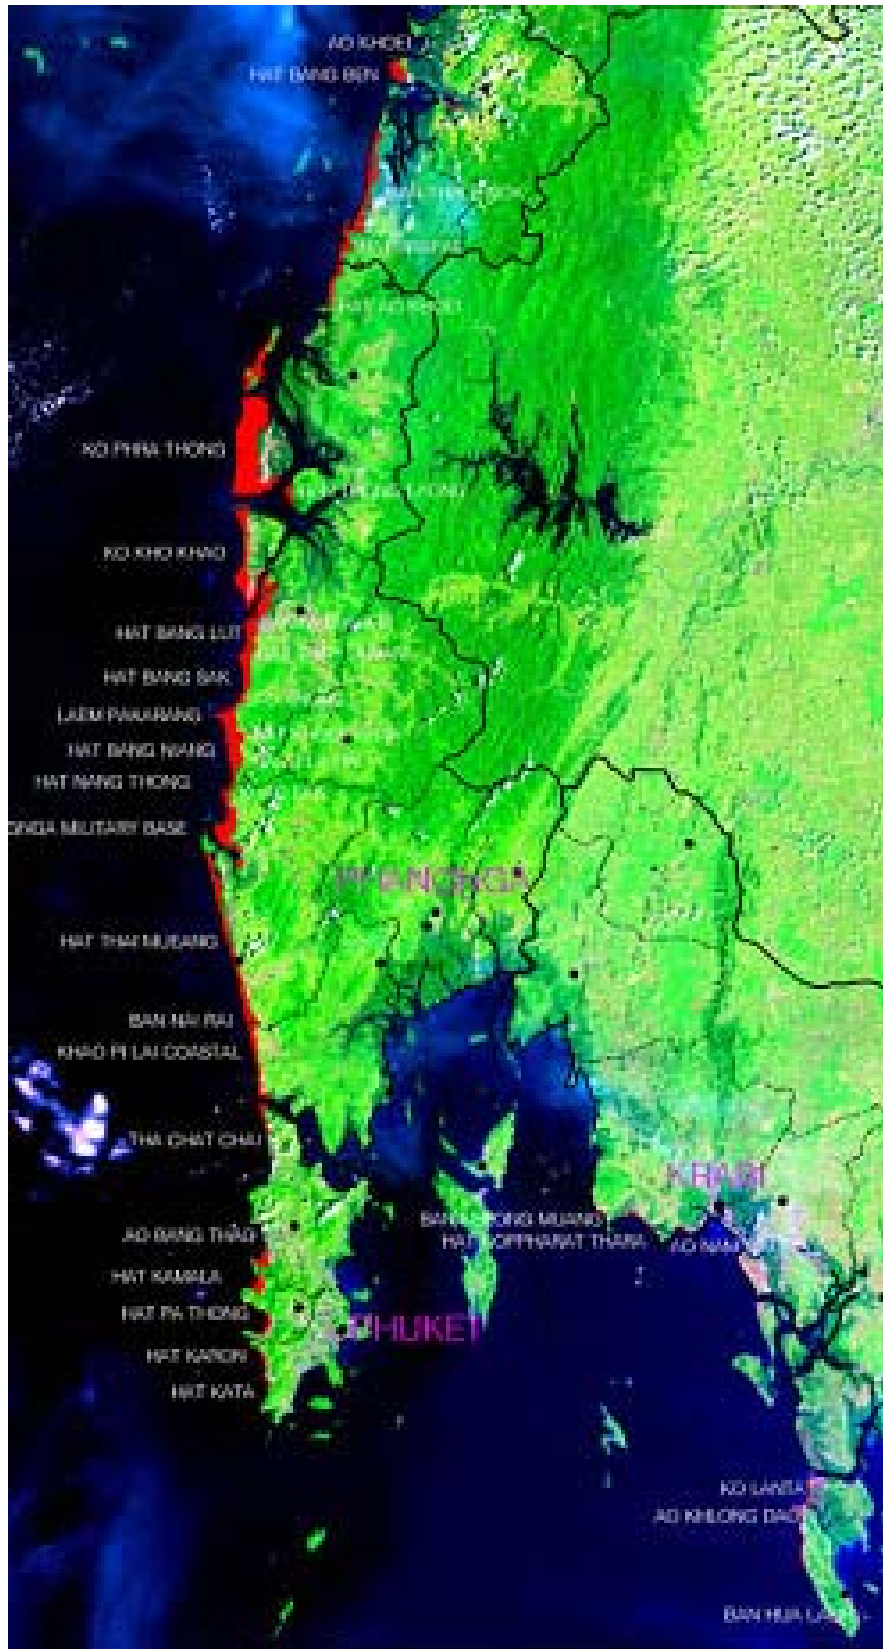
Fig. 1 False Color Composite LANDSAT 5-TM images indicate coastal damage in the red boundary after the tsunami impact along the Andaman Sea, Thailand.

The wave could reach approximately 200-1,500 meters from shoreline at 2-5 meters elevation above mean sea level, shown in Table 1. and Fig. 1

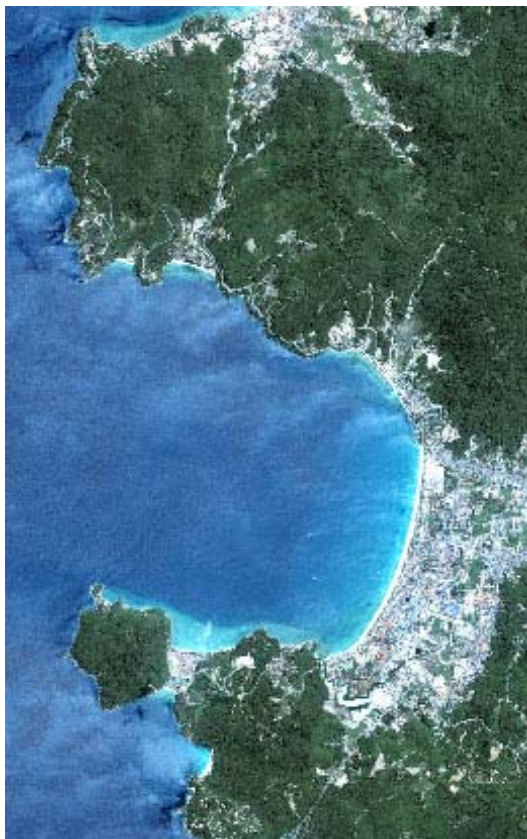
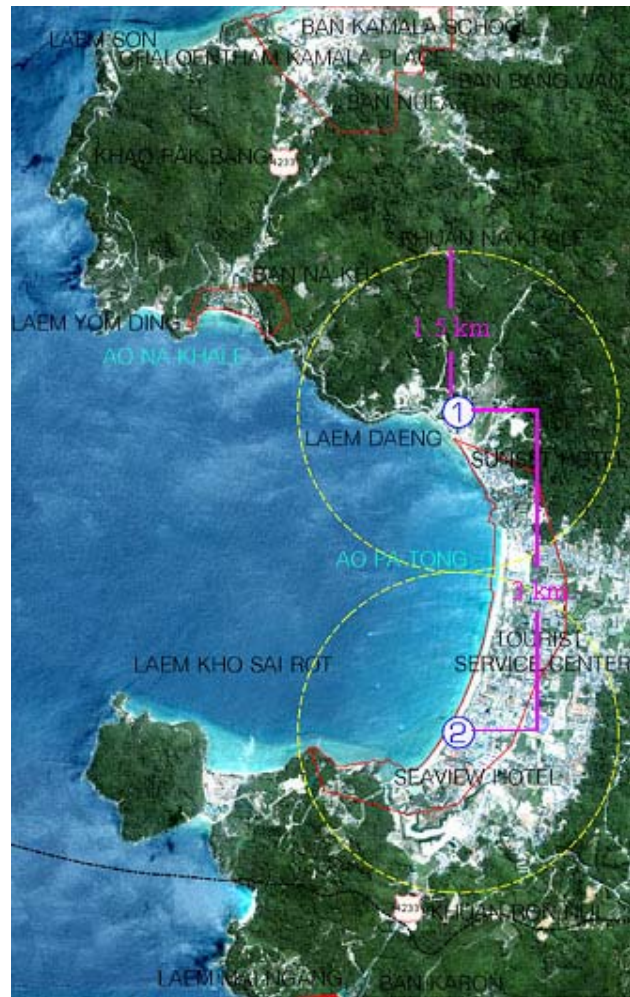
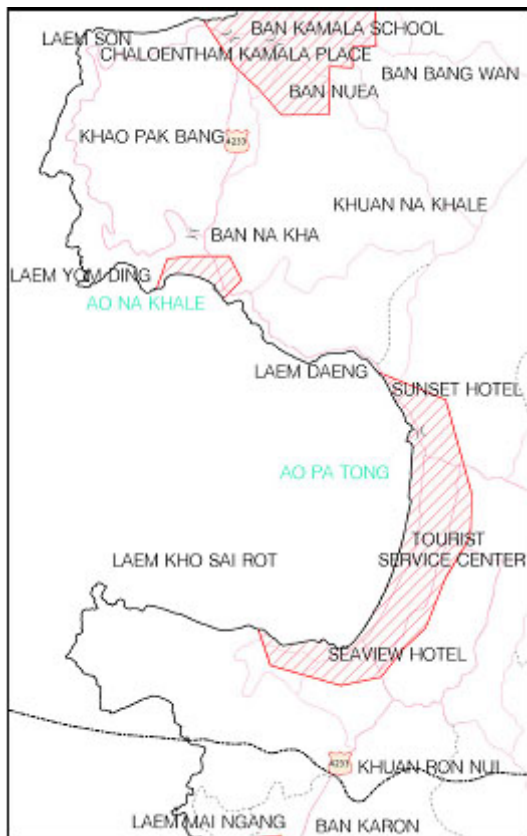
Fig. 2 IKONOS natural color image acquired on April 21, 2005 overlaid with affected area in Phuket coastal plain indicated by red boundary covering kamala beach-Patong Beach, Phuket province. The two sites have warning tower installed about 3 km. from each other and communities can hear the warning sirens within 1.5 kilometers radius.

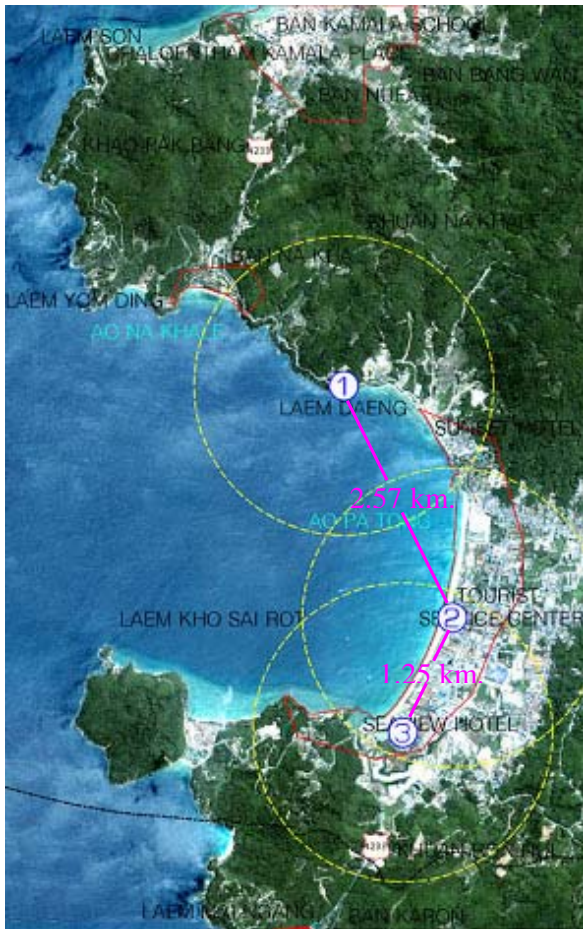
Fig. 3 IKONOS Natural Color image acquired on April 21, 2005 overlaid with affected area in Phuket coastal plain indicated by red boundary covering kamala beach-Patong Beach, Phuket province. Three sites were selected with each warning tower located about 1.25-2.57 km. from each other and people can hear the warning siren within 1.5 kilometers radius.

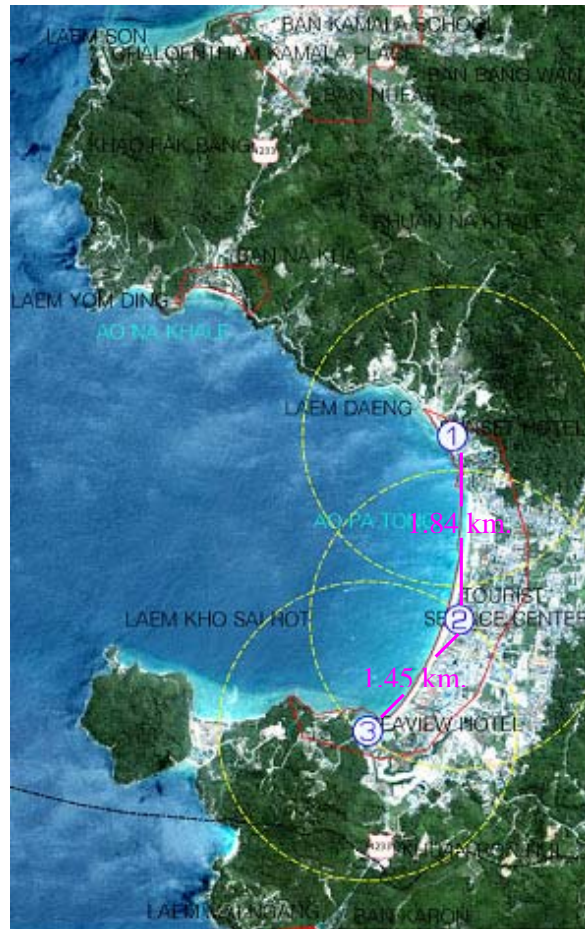
Fig. 4 IKONOS Natural Color image acquired on April 21, 2005 overlaid with affected area in Phuket coastal plain indicated by red boundary covering kamala beach-Patong Beach, Phuket province. The suitable positions of the warning tower at Patong Beach are three sites. The first is Sunset Hotel, the second is Tourist Service Center and the third is Seaview Hotel. Each warning tower is located about 1.45 – 1.84 km. distance and people can hear the warning sirens within 1.5 km. radius.

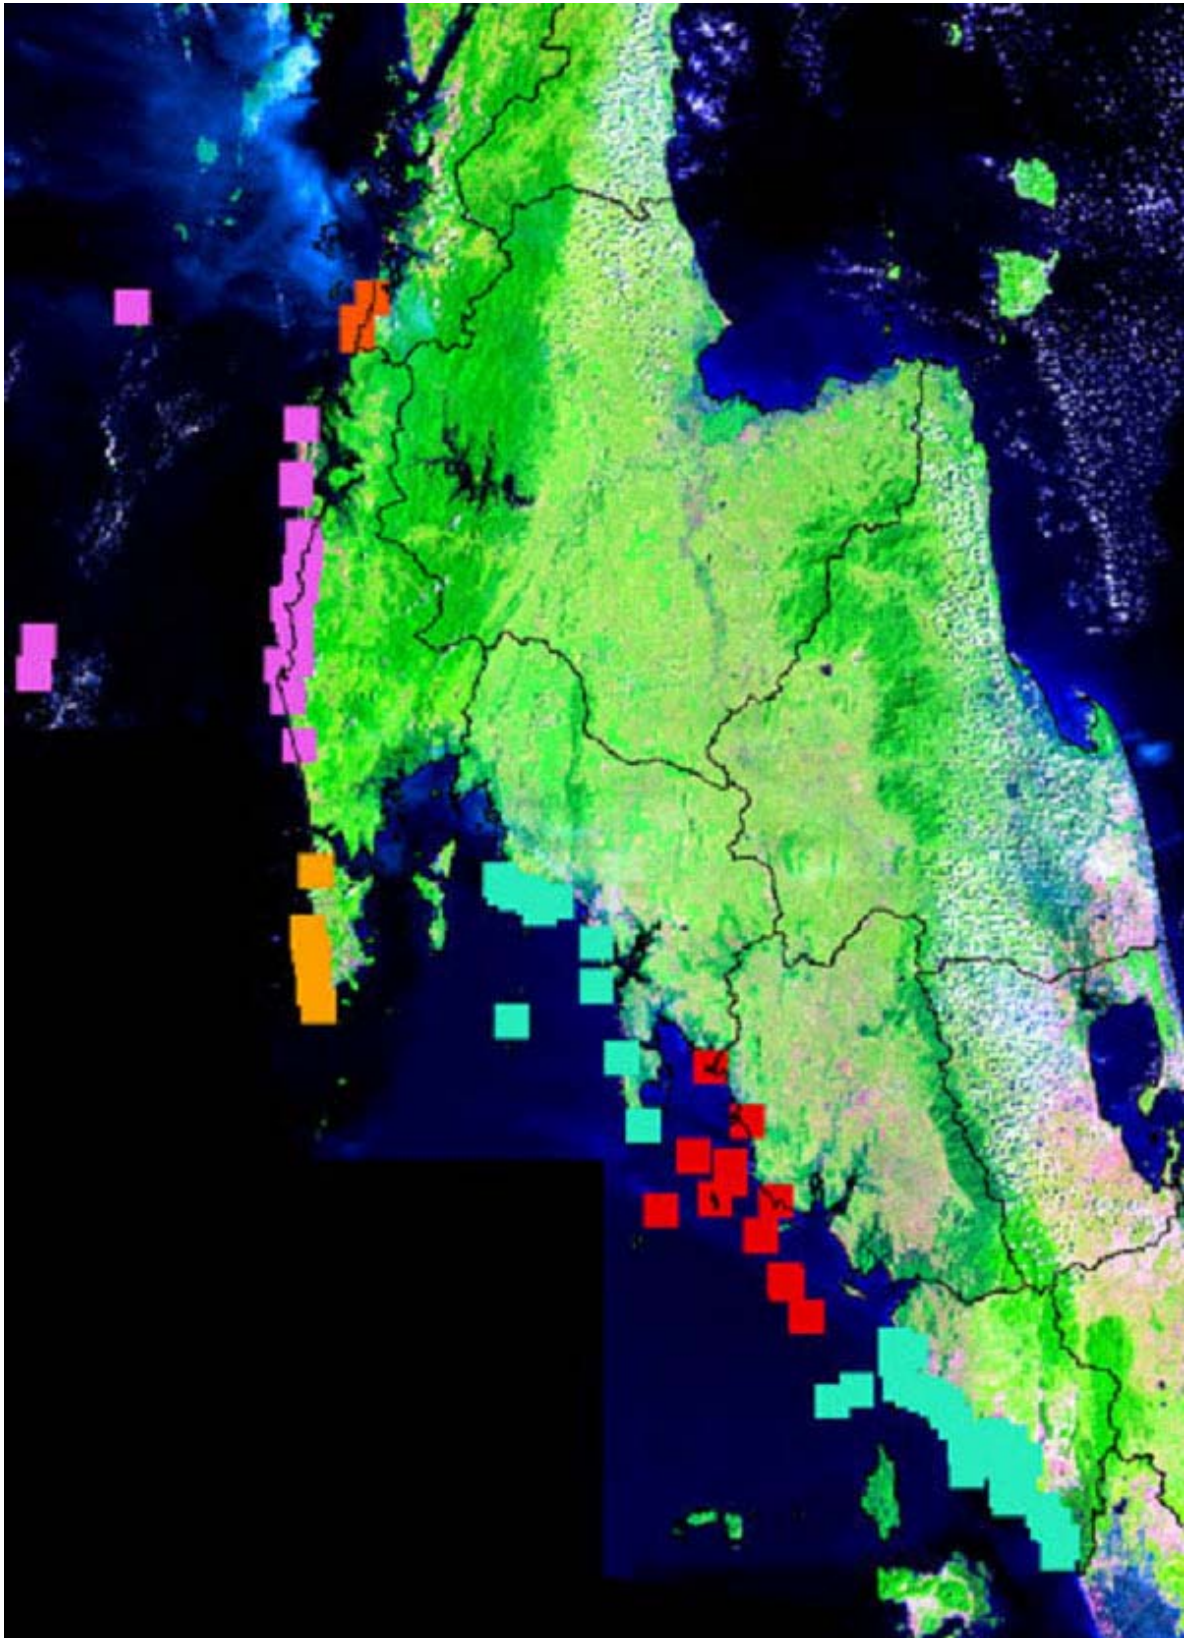
Fig.5 The suitable position of tsunami warning tower in 6 provinces along the Andaman sea south of Thailand.
